Longwall Shield Recovery, Using Phenolic Foam Injection for Gob Control As An Alternative to Recovery Mesh

James D Pile, Geotechnical Engineer
BHP Billiton
Waterflow, NM

32nd International Conference on Ground Control in Mining

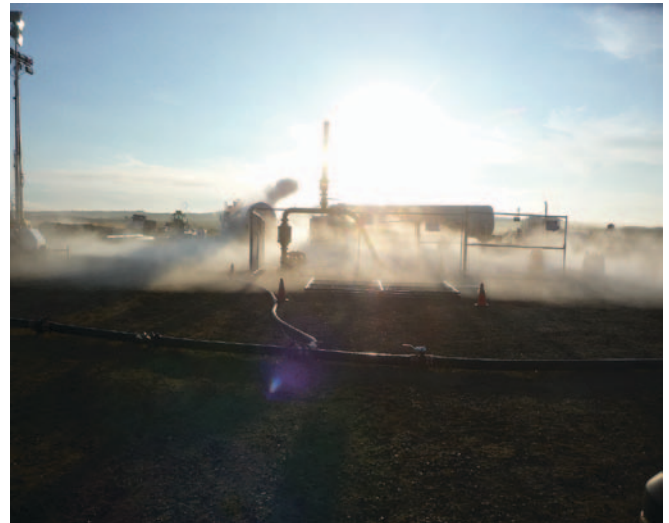
Figure 1. Nitrogen injection on gob vent borehole.

Immediately after the ignition the mine was successfully evacuated in a safe and timely manner, without incident or injury. Within four hours of the occurrence, nitrogen was being injected directly into the area of the ignition, in quantity and from the surface (Figure 1). Full control of the situation was established within 48 hours of the incident, at which point the mine was faced with an exciting and stimulating technical possibility: if the affected longwall panel could be successfully isolated from the rest of the mine, then the remainder of the workings could be returned to regular operation and the conventional practice of having to seal the portals for a defined period of time could be avoided.

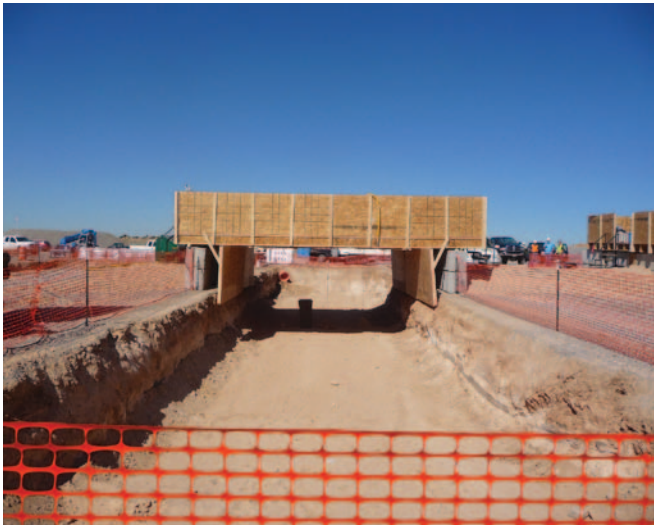
Figure 2. Test trench.

Cementitious and foam products were tested to determine their ability, and suitability, to seal the active longwall panel remotely from the surface (Figures 2 through 6).

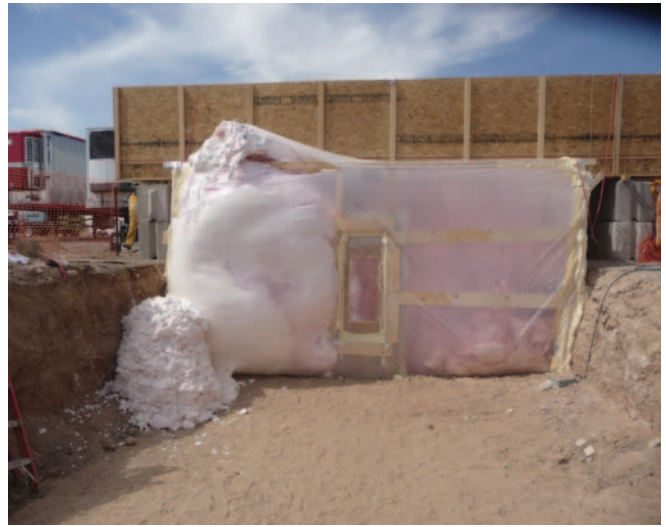
Figure 5. Finish of phenolic foam testing.

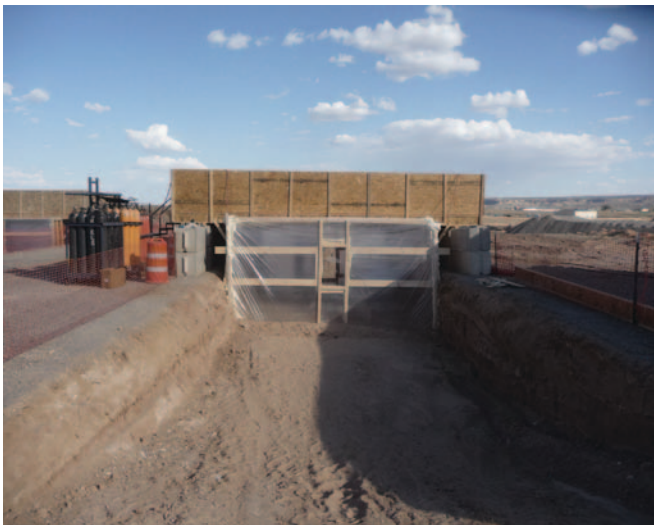
Figure 3. Test trench with nitrogen inertisation.

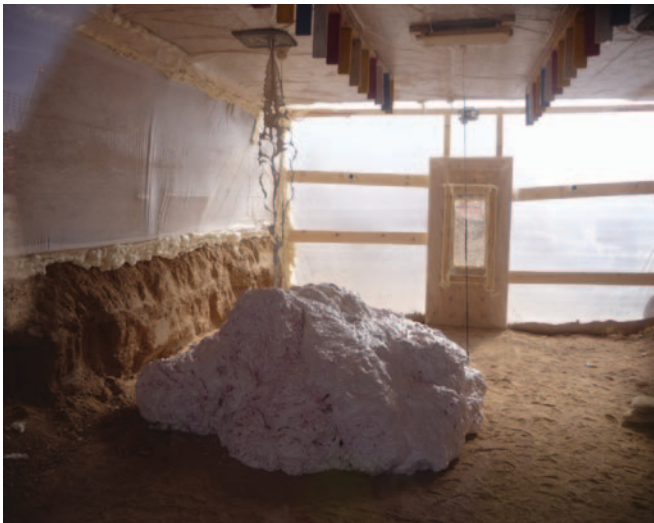
Figure 4. Start of phenolic foam testing.

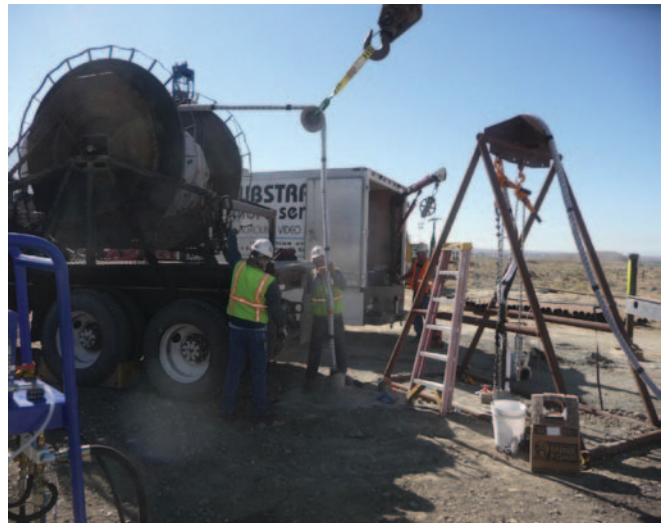
Figure 7. Lowering hoses from surface.

Phenolic foam was chosen, and the longwall panel was successfully sealed with five in-mine ventilation control structures, remotely placed from the surface at depths of approximately 750 to 900 ft (230 to 275 m). The first two structures were placed using two injection boreholes and two video camera boreholes each (Figures 7 and 8). The last three structures were each placed with a single injection borehole and a single video camera borehole.

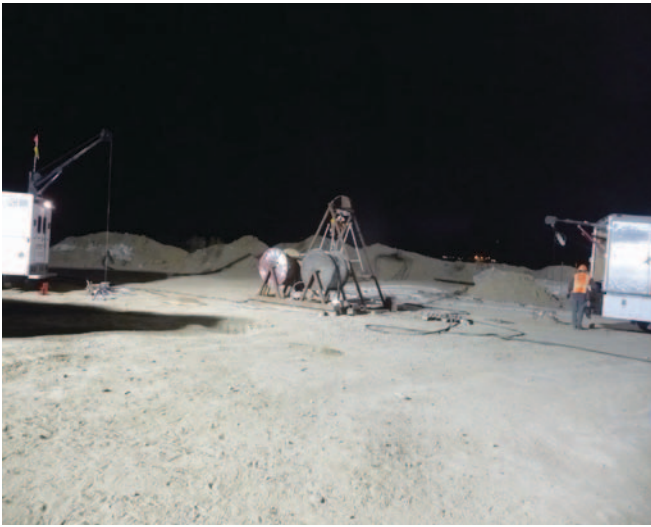
Figure 8. Pumping from surface.

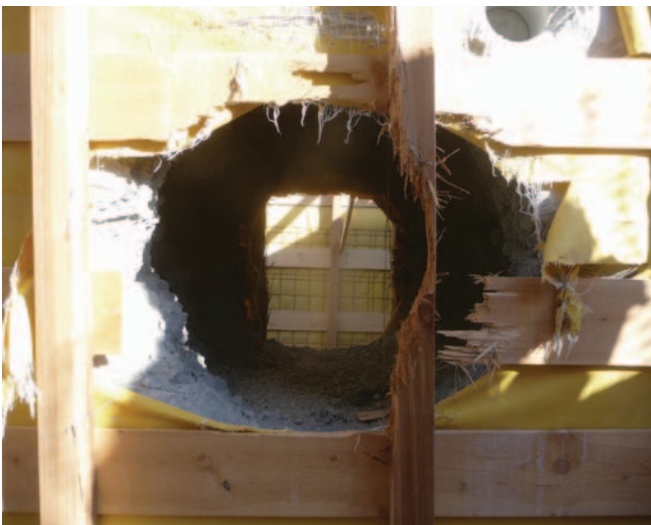
Figure 9. Test breaching 50 psi (0.34 MPa) seal.

After the regulatorily mandated period of time had elapsed, access and ventilation were reestablished to the affected longwall face in readiness for gob consolidation. At the time of the ignition, the longwall face was approximately 3,100 ft (945 m) short of its planned recovery line, and the headgate drive and crawler-mounted tailpiece were partway along a chain pillar between crosscuts. A new set of recovery chutes were driven, and the pillar was split. The 50 psi (0.34 MPa) seals, stoppings and in-mine ventilation control structures were breached (Figures 9 through 12).

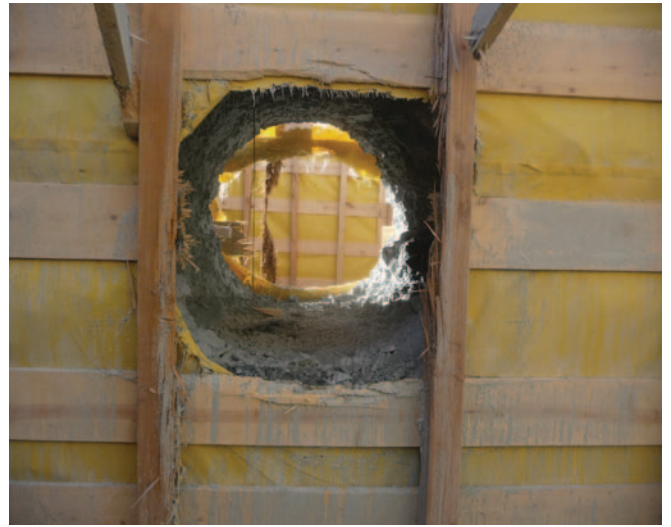
Figure 10. Test breaching 50 psi (0.34 MPa) seal.

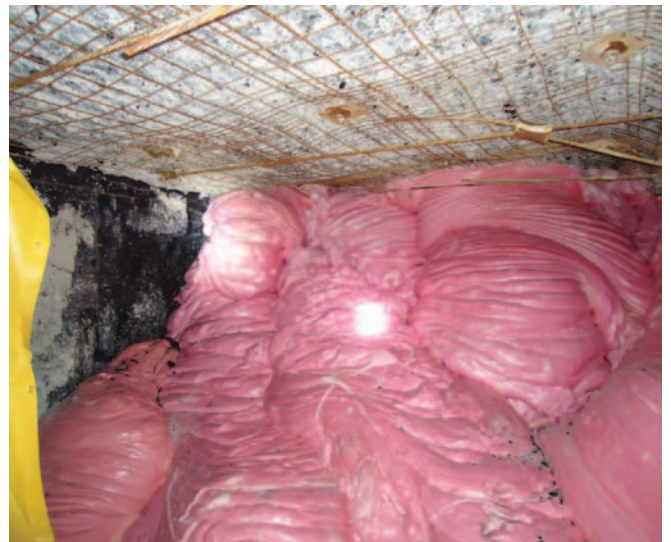
Figure 11. Phenolic foam underground.

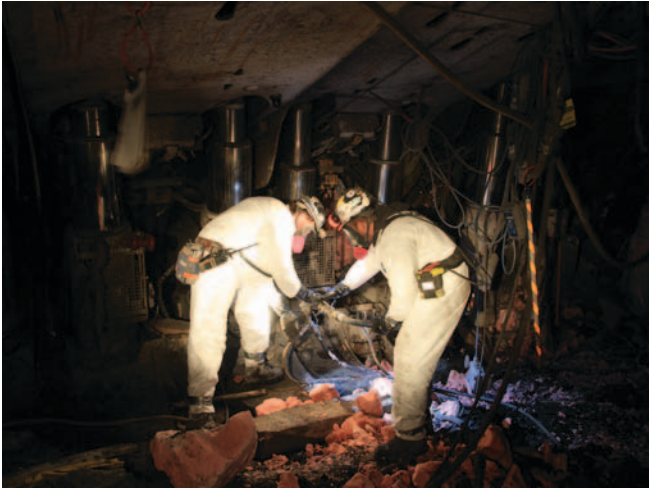
Figure 14. Pumping and changing drill strings.

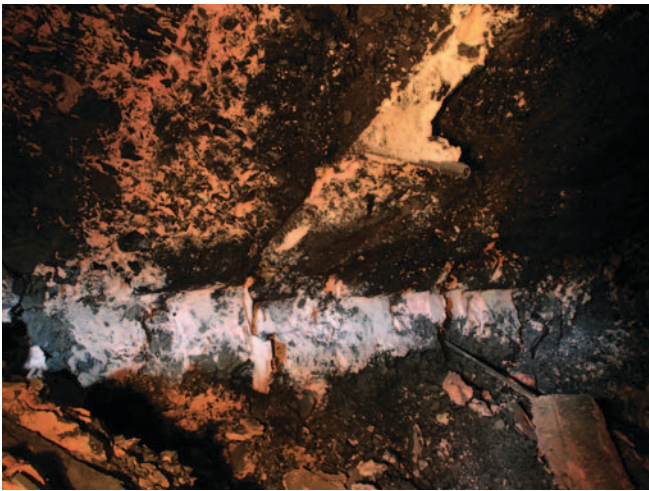
Figure 15. Drill strings in gob between shield pairs.

It was intended to drill two holes between, or at the edge, of each shield. An upper one, towards the back of the canopy/caving beam and at an angle of approximately 45°, and a lower one at chest height straight back into the gob. Holes were initially drilled to a depth of approximately 6 ft (1.8 m). Each drill string was drilled in until the proximal end of the threaded coupler was flush with the back of the shield/gob line. The drill string was then disconnected from the threaded coupler on the end of the striker bar and left in position, ready for injection. Further threaded couplers were modified by the addition of staple-lock couplers to one of their ends for connection to the mixing gun. The mixing gun could then be connected to these modified threaded couplers with a single staple, and pumping started. This system allowed for a safe and simple transfer from one drill string to the next (Figure 14). Once pumping on a specific drill string was finished, the proximal 10 ft (3 m) section was then wound back out of the threaded coupler whenever possible, leaving the distal 6 ft (1.8 m) section behind in the gob. This helped to clear the working area of unwanted obstructions, and minimised the potential risk of drill string hang-ups on the shields when they were pulled, and then possibly getting thrown around the work area. It also allowed the remaining 6 ft (1.8 m) sections to act as 'rib' bolts, thereby helping to reinforce the gob (Figure 15).

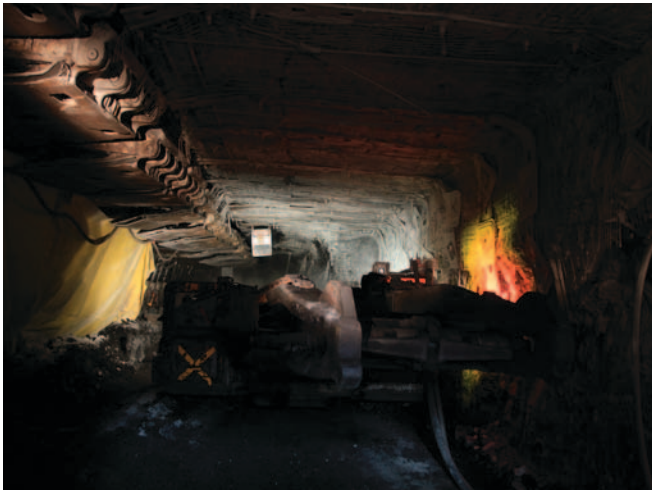
Figure 16. Miner tramming to take cut.

The shearers, drives and panline were recovered once gob consolidation had been effected. The face was then widened by about 10 ft with a continuous miner, bolted and dusted to provide sufficient clearance for shield recovery (Figures 16 through 19). Widening was done one section at a time: tailgate to Chute 1, Chute 1 to Chute 2, Chute 2 to Chute 3, and Chute 3 to headgate. To prevent damage to the shields, the left hand end of the miner drum was modified.

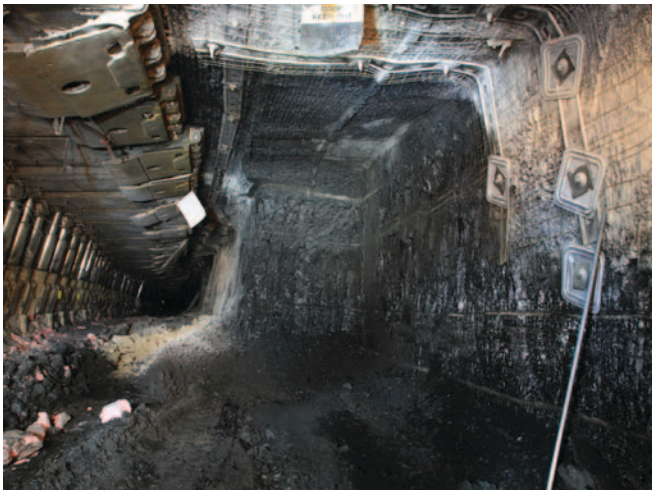
Figure 17. Cut taken.

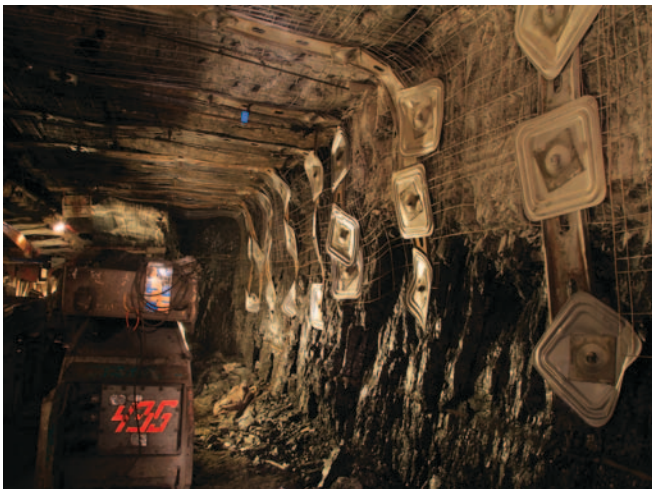
Figure 18. Bolting.

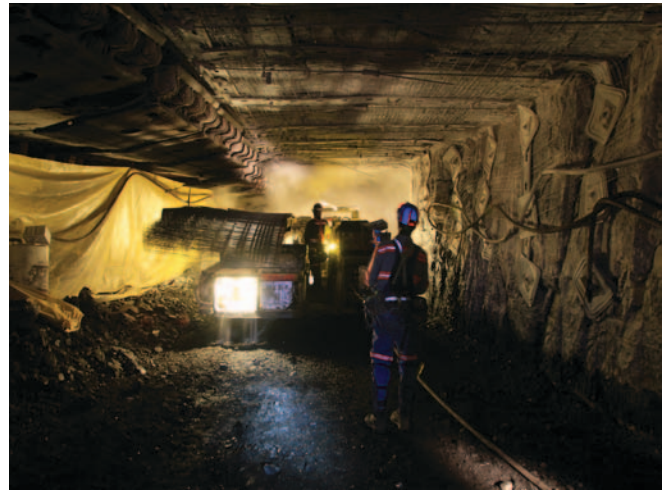
Figure 19. Dusting.

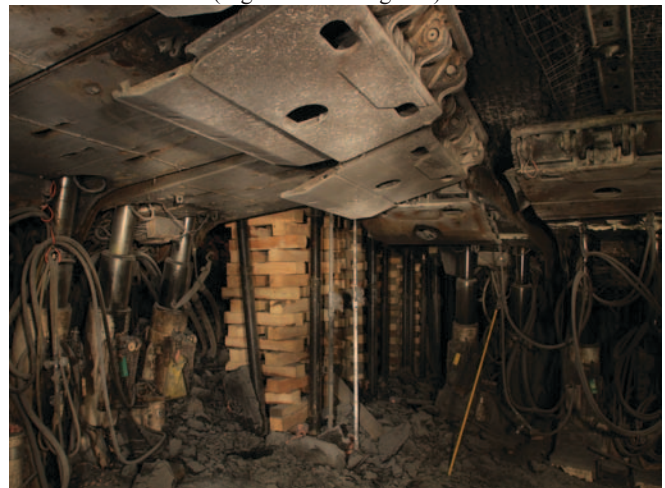
Figure 20. Walkers at Shield 116.

injection of foam was as uniform as planned, the recovery face conditions were excellent. So good, in fact, that the gob was held back at a negative 'angle of repose', with the backs of multiple shields quite clearly imprinted in it. Most importantly, all the conditions were significantly better than they would have been without recovery mesh or foam. Without either of these, gob flushing would have been almost inevitable, and the face could have been inundated (Figures 20 through 27).

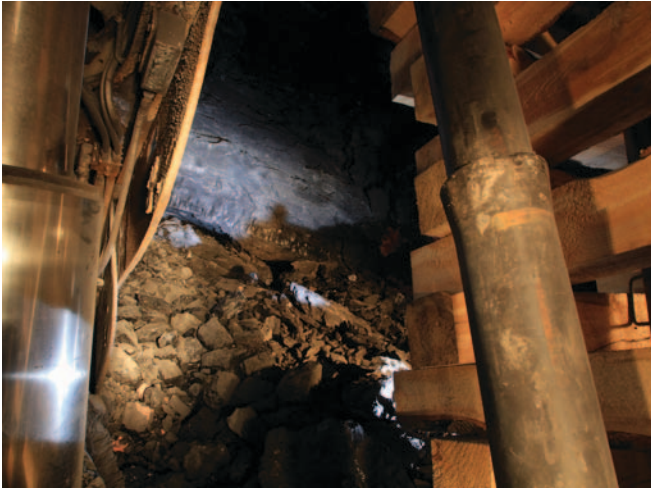
Figure 21. Minor flushing.

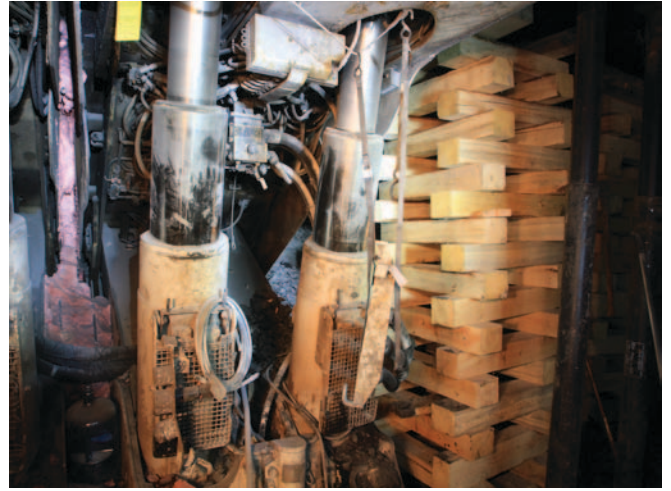
Figure 24. Walkers at Shield 59.

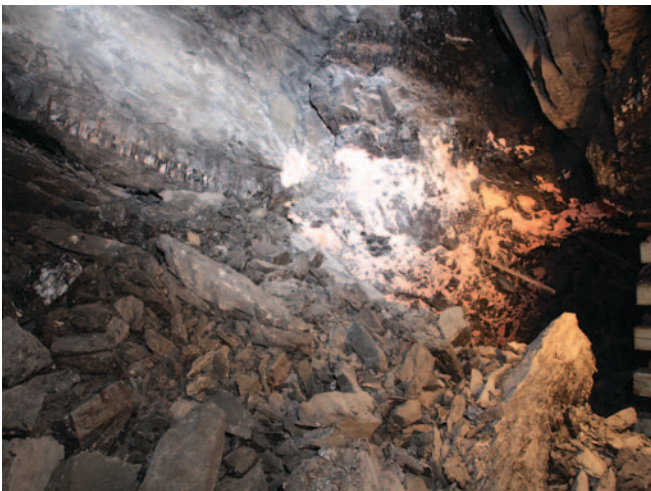
Figure 22. Minor flushing, and excellent gob control.

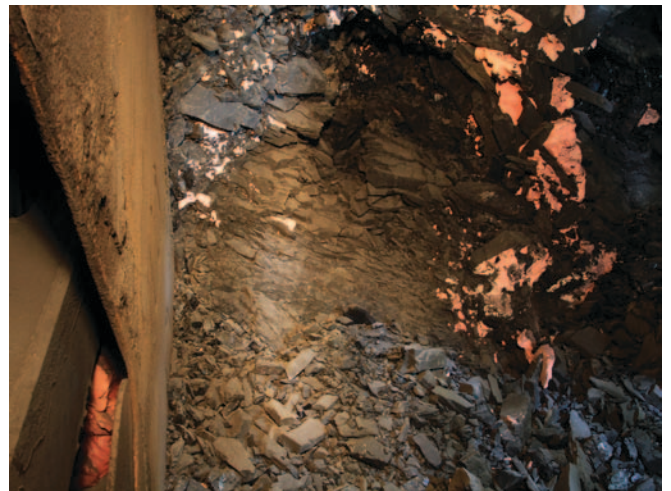
Figure 25. Minor flushing.

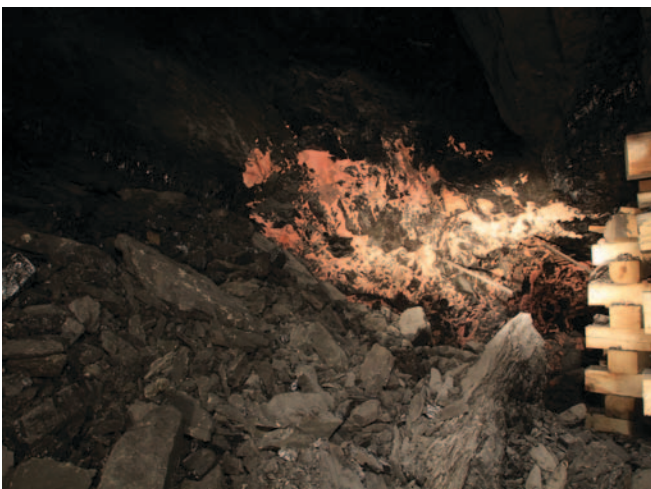
Figure 23. Minor flushing, and excellent gob control.

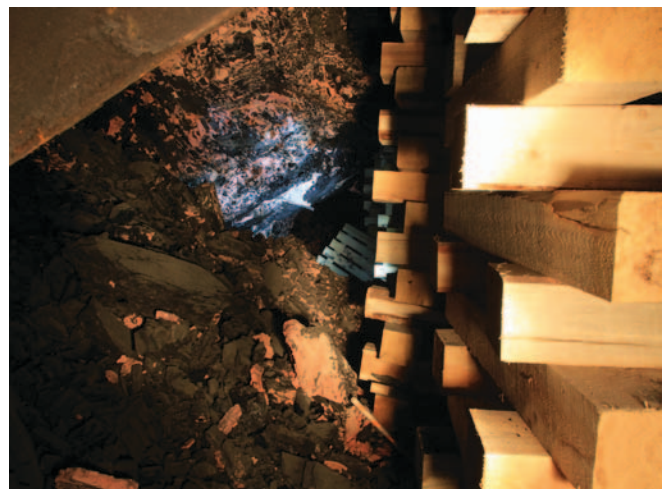
Figure 26. Minor flushing.
