## STEERING COMMITTEE REPORT TO THE HEALTH & SAFETY COMMITTEE OF SOLID ENERGY NEW ZEALAND LIMITED ON THE RE-ENTRY OPTIONS INTO THE PIKE RIVER MINE DRIFT

### EXECUTIVE SUMMARY

1. SENZ has been contracted to determine whether a technically feasible, safe and financially credible means of re-entry to into the Pike River Mine Drift<sup>1</sup> is possible.

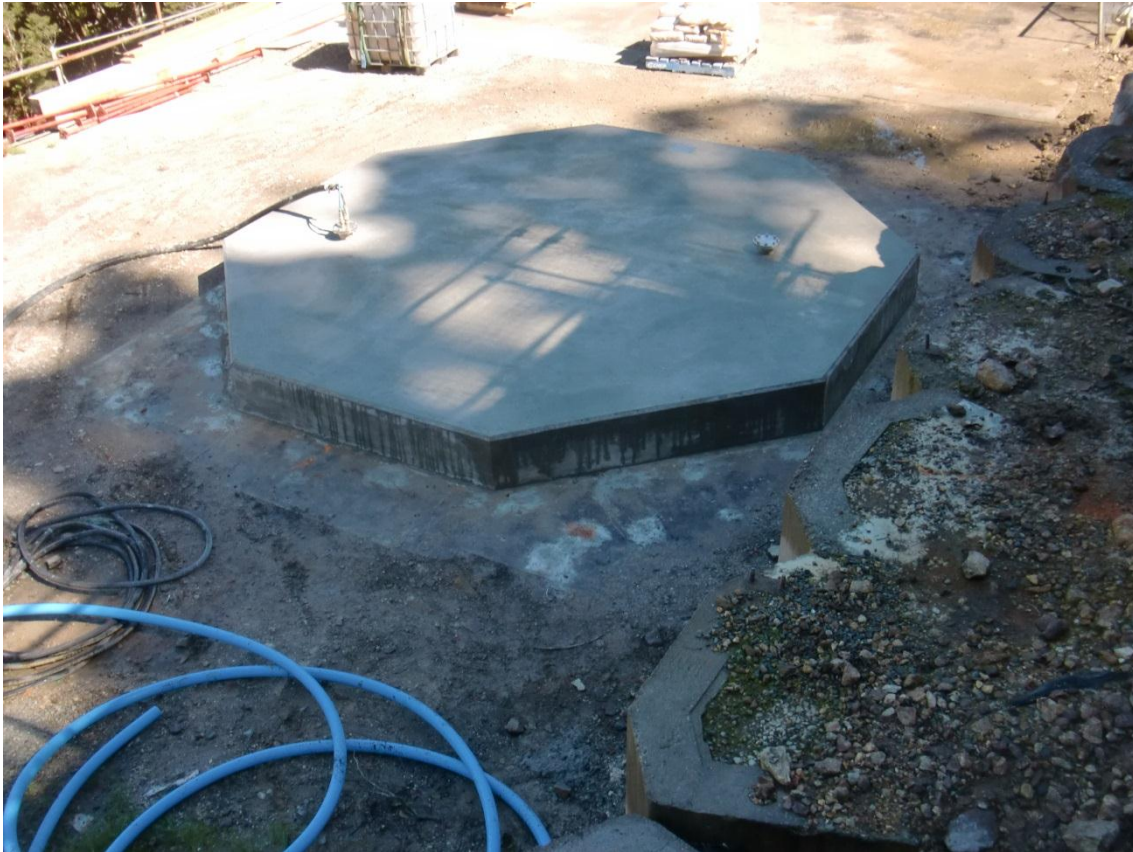
**Figure 5:** Shaft collar after sealing work completed.

29. Initial work involving the use of NZ Defence Force aircraft and personnel was completed in October 2013 leaving the shaft collar ready for the sealing work to commence. This involved the placement of a plug at the intersection of the shaft and the Alimak rise, approximately 90m below the surface. Once this step was completed, a concrete “foundation” was poured at the base of the shaft section and an expanding foam product used to fill the shaft to near the surface. A further concrete plug was then placed at the collar. This work had the immediate effect of increasing the volume of methane reporting to the portal of the drift, indicating the Mine upcast shaft was effectively sealed.

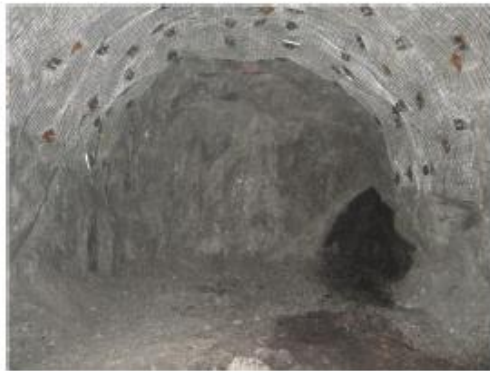
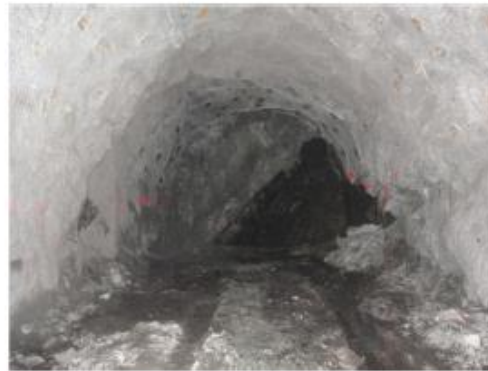
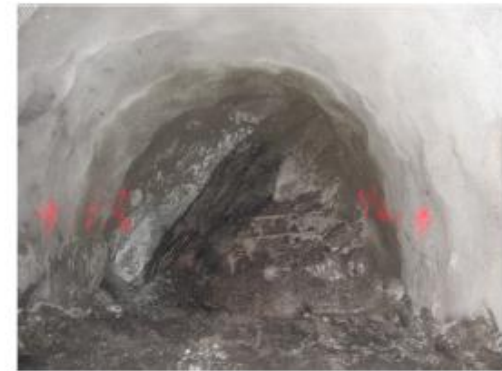
*2095 m*

*2098 m*

*2099 m*

**Figure 11:** A series of photos of strata at 2100m mark showing the intersection of the drift with a coal seam (Paparoa Seam). As the face of the drift advances, it passes through the seam which moves from the bottom right of the face to the left hand side of the drift face. Note loss or 'arch' and use of shotcrete as face advances

66. The Steering Committee noted the general perception of the strata conditions being that of a solid rock tunnel and instigated further review to ascertain the actual strata and gas conditions in the drift. **(Figure 10 – next page)**
67. Evidence indicated:
- Presence of a 4m thick coal seam, and beyond **(Figure 11 – next page)**;
  - a further 6-10m of very poor ground, and beyond;
  - a further 20m of carbonaceous material, coal and gouge material and;
  - High gas levels emitting from horizontal exploratory holes.

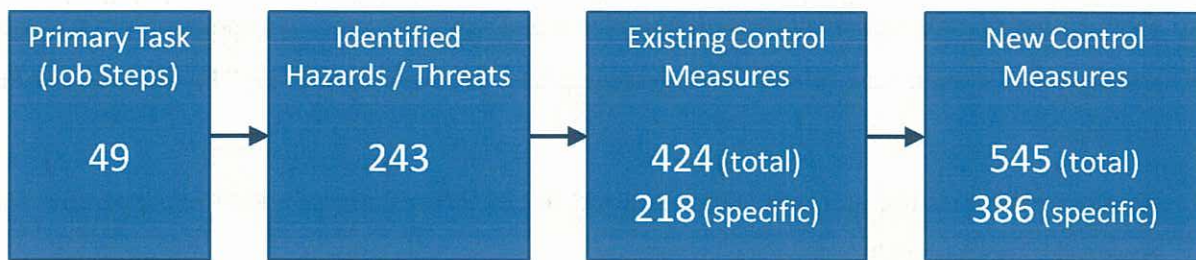
Figure 1: Summary of results from Pike River drift re-entry WRAC assessment (Knowles, 2013)

This WRAC identified 49 Job Step Activities that formed the basis for the risk analysis process. The list of Job Step Activities is listed in Table 1. As indicated in Figure 1, the WRAC process identified 243 potential hazards/threats related to the job step and listed a total of 424 existing control and 545 new controls to address the hazards/threats. In condensing the list of actions to remove duplication, the WRAC process identified 218 specific existing controls and 386 specific new controls to be incorporated into the design and safety management systems for the project.

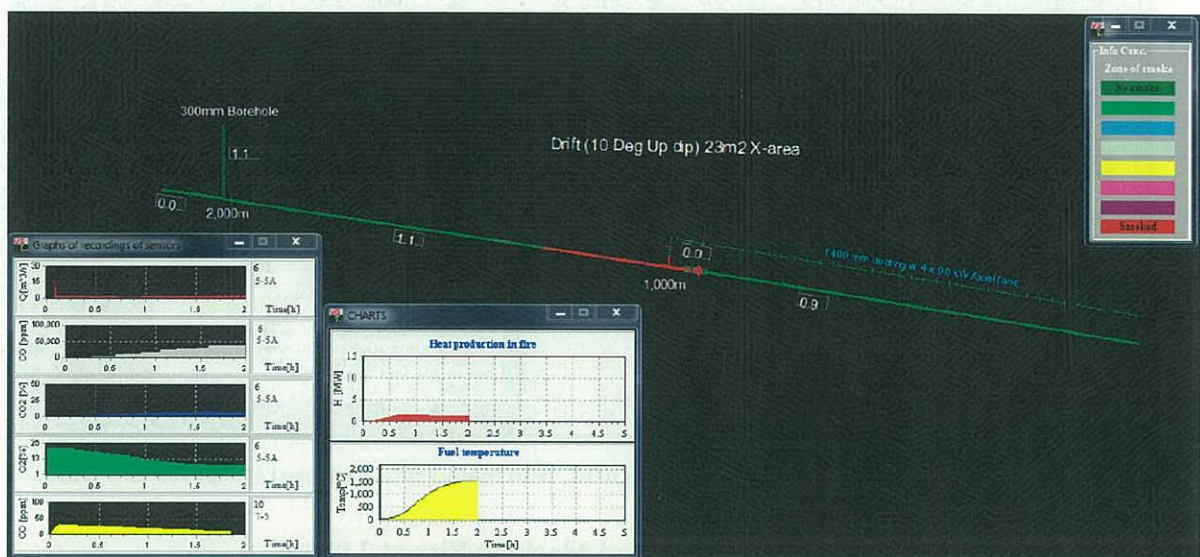
Figure 3: Ventgraph fire simulation at 1,000m in drift, with main ventilation stopped (Wu and Gillies, 2014)

Figure 3 shows the extent of the heavily smoked zone along with modelled gas concentrations for the initial 2 hour period following the start of the fire.

Modelling of this scenario indicates that the CO levels reach 6.67% at about 3.59 hours (215 mins) and CO levels remained at that level. The CO levels inbye of fire therefore do not reach the lower explosive limit of CO (12.5%).

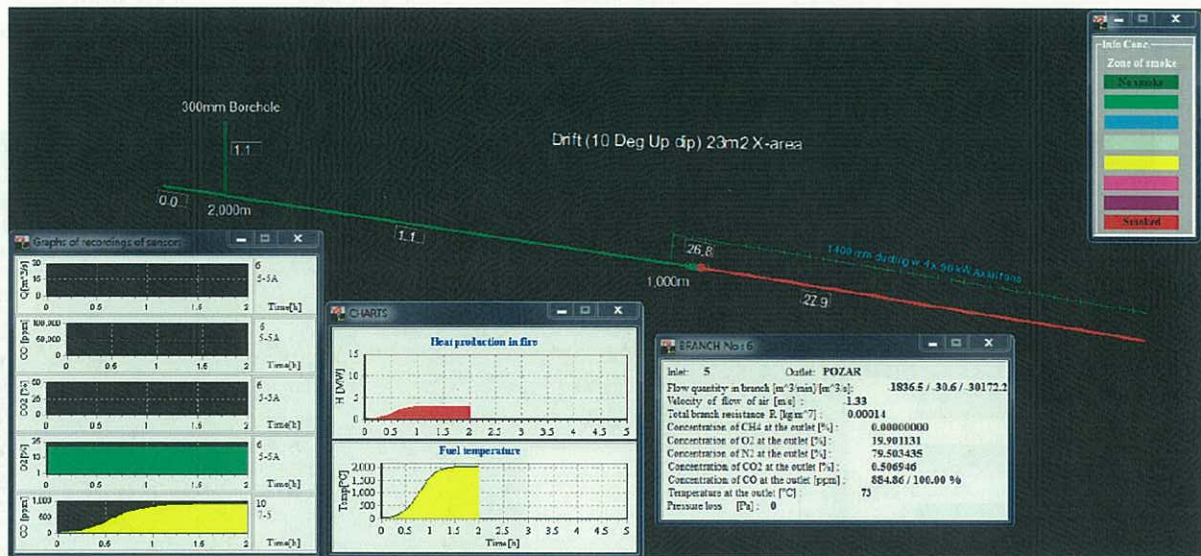
**Figure 4: Ventgraph fire simulation at 1,000m in drift, with main ventilation operating (Wu and Gillies, 2014)**

Figure 4 shows the extent of the heavily smoked zone along with modelled gas concentrations, for the initial 2 hour period following the start of the fire. The predicted heat outputs from the vehicle fire and expected fuel temperatures over the time are also shown.

Smoke and combustion products reached the portal at around 15 minutes given the speed of ventilation air flow (about 1.13 m/s). Modelling 25.7 m<sup>3</sup>/s of air flow over the fire is sufficient to support and maintain an oxygen rich fire situation during the course of the fire event.

Continuing to operate the portal fans ensures no dangerous gas accumulation at the site of the fire. However, with continued operation of the main fans, combustion products will flow over personnel making their way outbye toward the drift portal.

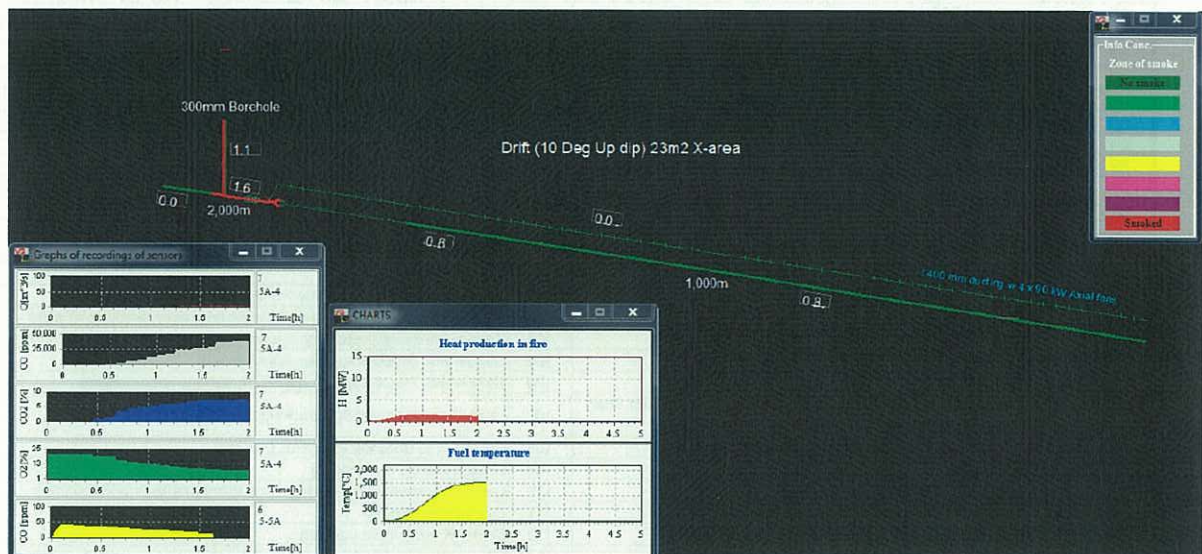
Figure 5: Ventgraph fire simulation at 2,000m in drift, with main ventilation stopped (Wu and Gillies, 2014)

- The simulation considered natural ventilation effects, and evaluated the time for products of combustion to accumulate and reach explosive level at the source of the fire (2,000 m in from portal).

Figure 5 shows the extent of the heavily smoked zone along with modelled gas concentrations for the initial 2 hour period following the start of the fire. Modelling of this scenario indicates that the CO levels reach 6.67% at about 3.65 hours (219 minutes) and CO levels remained at that level.
